**Board of Equalization Building**  
450 N Street, Sacramento, CA 95814  
**Corroded Drain Line Investigation**  
**Prepared for DGS**

Interactive Resources Project No. 2011-099-01  
IDGS Contract No. 3158936 (BPM #028)

November 25, 2013

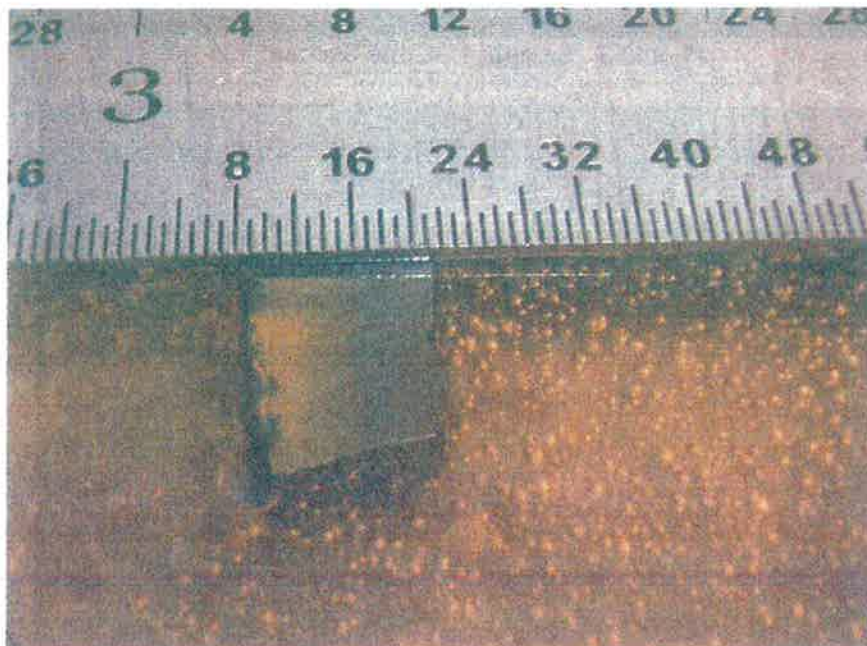
Photo 68 - Sample 6 - Cross Section

Cross sections of pipe samples that had indicated corrosion were polished and visually examined to determine the extent of corrosion. The loss in wall thickness was measured with a fine scale having 1/64" increments. The original wall thickness was also determined from an area without corrosion for reference. The results are presented in Table 2. These measurements indicated loss in pipe wall thickness of as much as 77%. The macrographs corresponding to thickness measurement data are presented in Photos 64 through 77.

| TEI Sample No. | Sample Type | Location | Date Sampled | Observations | Laboratory Thickness Measurements, inch | Overall Views Photo No. | Macrographs Photo No. | Macrographs Photo No. |
|---|---|---|---|--|--|---|---|---|
| 6 | Fitting, vent | 22 <sup>nd</sup> floor M-21 | 7/6/13 | Minimal corrosion, dark thick build up | N/A | 18, 19, 20 | 68 | 82 |

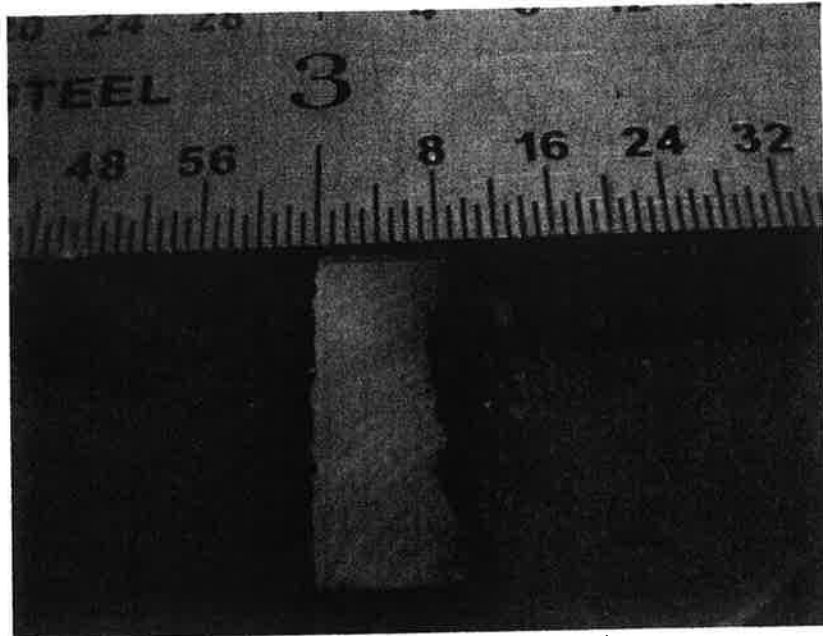
Photo 69 - Sample 8 - Cross Section

The unetched specimens exhibited randomly oriented fine graphite flakes. This was typical of all samples examined, although there were slight variations in the amount and size of the flakes (Photos 78 through 87). The dark porous areas on the cross sections are evidence of corrosion that has resulted in graphitization (Photos 78, 81, 83, and 84). This will be discussed in more detail later in this report.

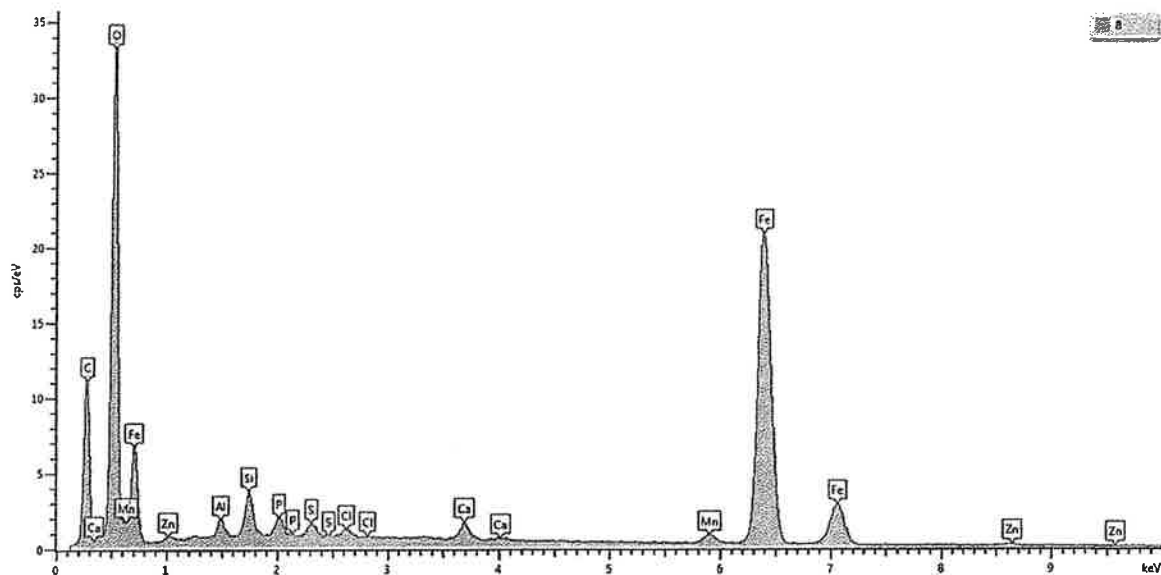
Figure 9  
Analysis of Deposits from Pipe Sample 8

The analysis of the deposits removed from the interior of the pipe sections indicated primarily the same data as the pipe samples (Figures 7 through 14). The exception was the higher amounts of chlorine on two of the samples (Figures 9 and 11). In general the
